MARINE INVESTIGATION REPORT
M00W0303

STRIKING OF A BRIDGE

TUGBOAT *MILLER RICHMOND* AND
BARGES *MILLER 201* AND *MILLER 206*
PITT RIVER HIGHWAY BRIDGE, BRITISH COLUMBIA
18 DECEMBER 2000

Report Number M00W0303

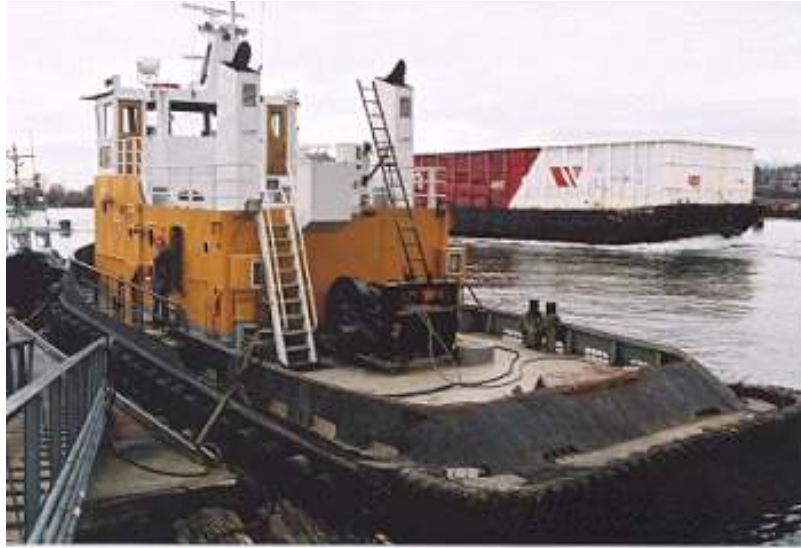
The *Miller Richmond* (See Photo 1) is a shallow draft steel tug with the superstructure located forward. The vessel is equipped with a hydraulically operated towing winch on the after deck with 670 metres (m) of 28 millimetre (mm) diameter steel wire towing cable, and a 25 mm diameter steel wire towing bridle approximately 17 m in length. Two 100 mm diameter polypropylene couplers, each approximately 10 m in length and fitted with eyes at both ends, are used to connect barges.

Photo 1. The tug *Miller Richmond*
